U.S. Chemical Safety and Hazard Investigation Board

Fatal Vessel Leak, Vapor Cloud Explosion, and Fire at Yenkin-Majestic Resin Plant

Columbus, OH | *Incident Date: April 8, 2021* | **No. 2021-04-I-OH**

Investigation Report

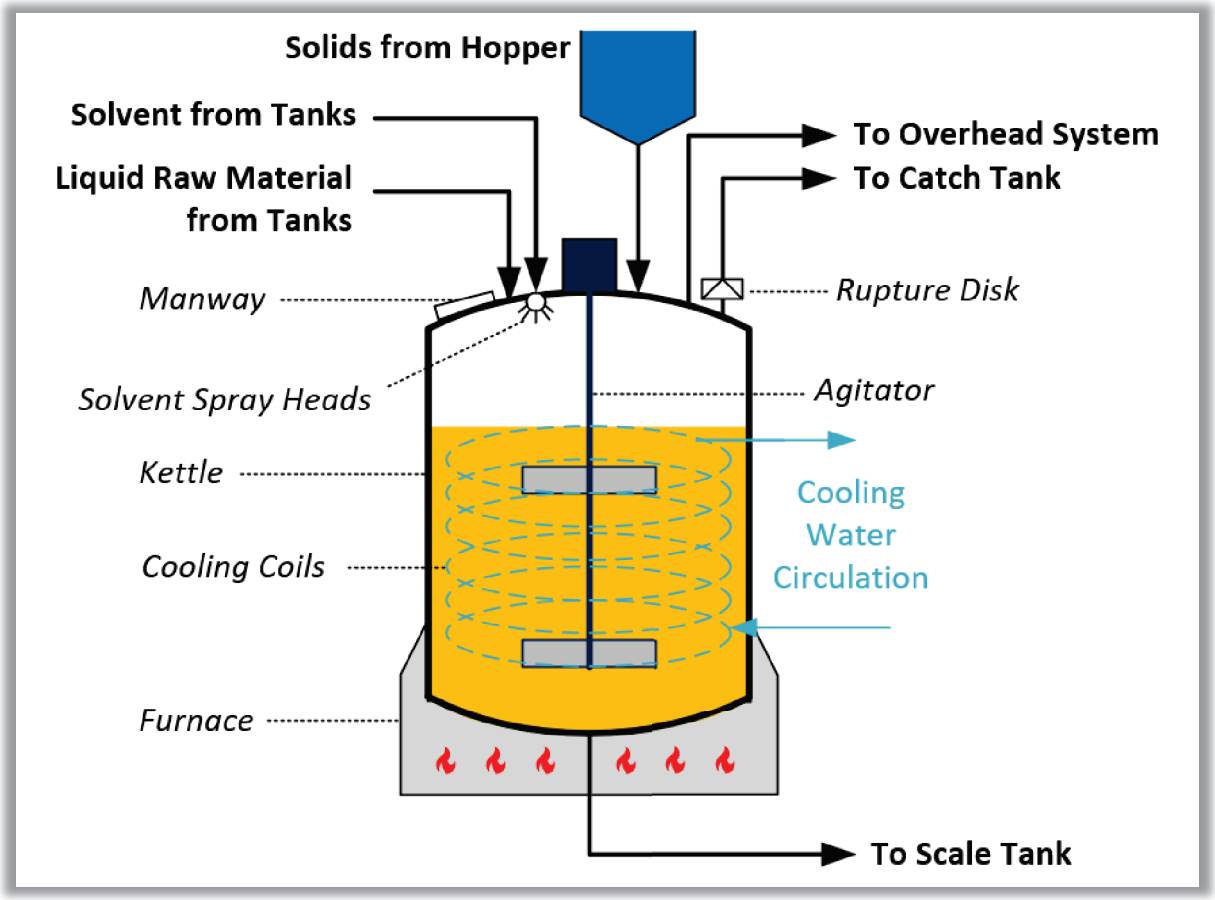
Figure 1. Simplified kettle drawing (not to scale). (Credit: CSB)

Figure 1 is a simplified drawing of a furnace-heated kettle. Liquid raw materials used in the batch process were piped from storage tanks into the top of the kettle. Solid ingredients could be dropped into the kettle from a

hopper through a designated opening on the kettle. Operators could also add solid material into the kettle in smaller quantities through the manway.[a]

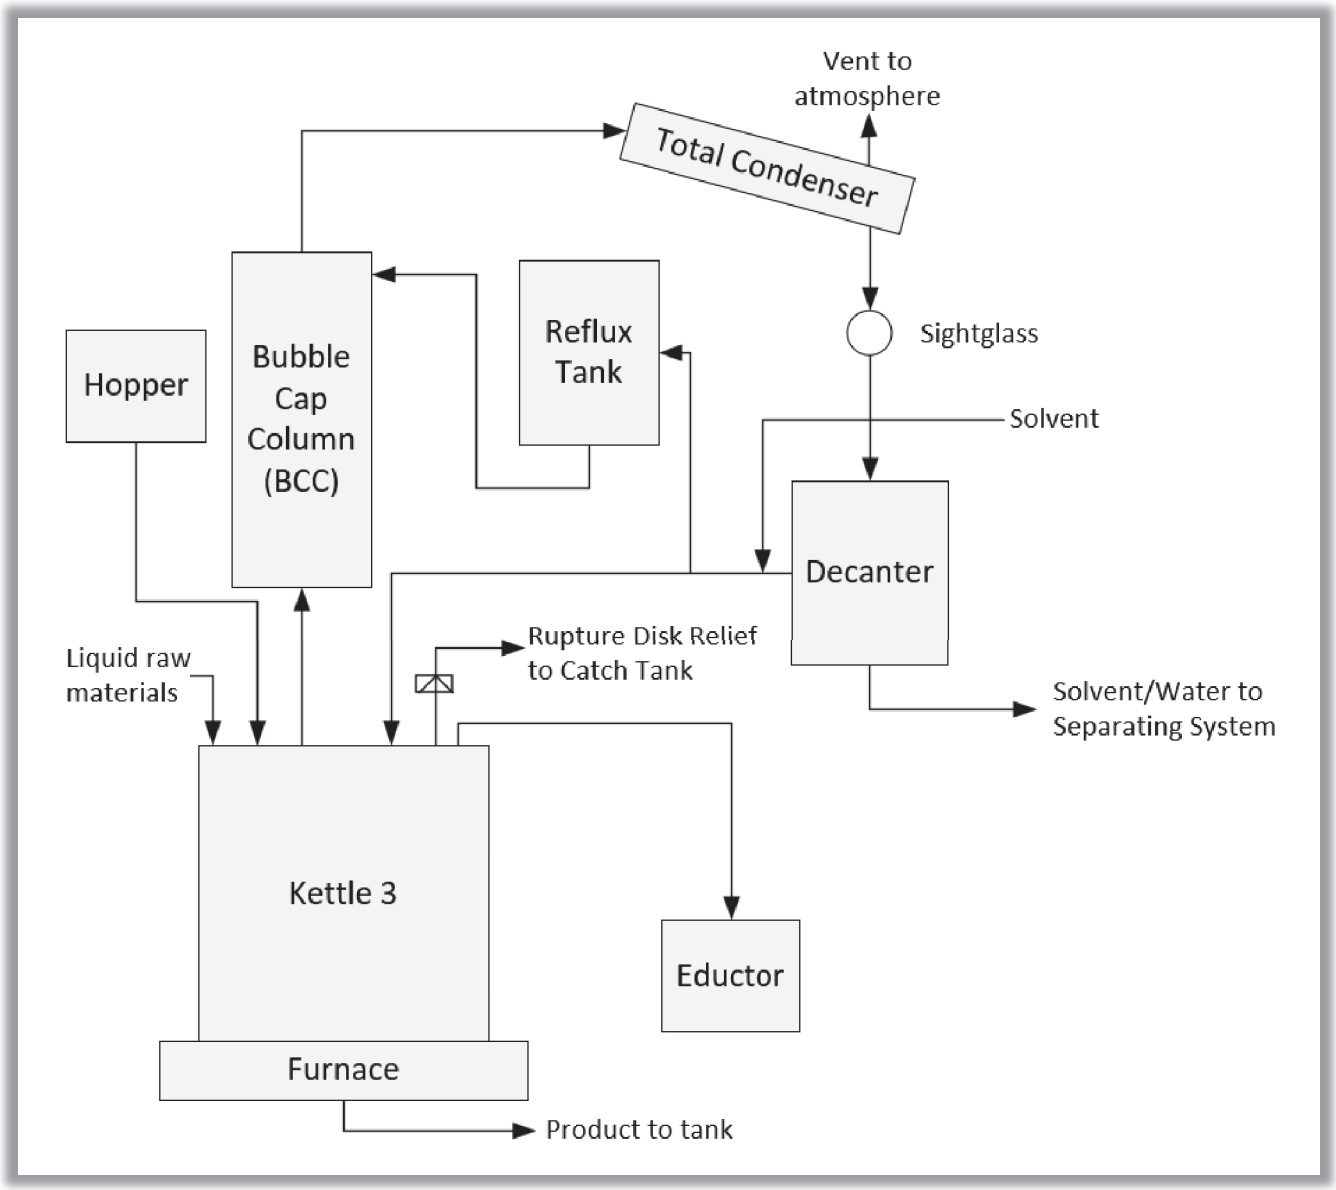
Figure 2. Simplified block diagram showing major equipment in the Kettle 3 system. (Credit: CSB)

On the night of the incident, a kettle used for the batch reactions, called Kettle 3, was being operated to produce an alkyd resin, which is a component used in some paints and clear coatings [5]. Kettle 3 was a cylindrical reactor with a diameter of 8 feet and a height of 7 feet. **Figure 2** shows most of the major equipment associated with Kettle 3 (valves and valve configuration not shown).[b] Kettle 3 was heated by a furnace located directly underneath it,[c] and the system also included auxiliary equipment to cool, separate, and recirculate process streams as needed for the resin production process. The Kettle 3 system operated open to the atmosphere, first passing through a bubble cap column acting as a scrubber and then through the total condenser, where any non-condensable gases, such as nitrogen, were directed through 3-inch atmospheric vent piping that was routed to the outside of the building.

Kettle 3 was typically operated at or near atmospheric pressure. The kettle was configured with a high-pressure alarm at 2 pounds per square inch gauge (psig), and an automatic high-pressure trip at 4 psig. The high-pressure trip activated the "emergency cooling" safety interlock,[a] which was designed to shut down the furnace and turn on cooling water to the coils to aid in reducing the temperature and pressure inside the kettle. The Kettle 3 emergency pressure-relief system also included one 8-inch rupture disk, used to protect the vessel from high-

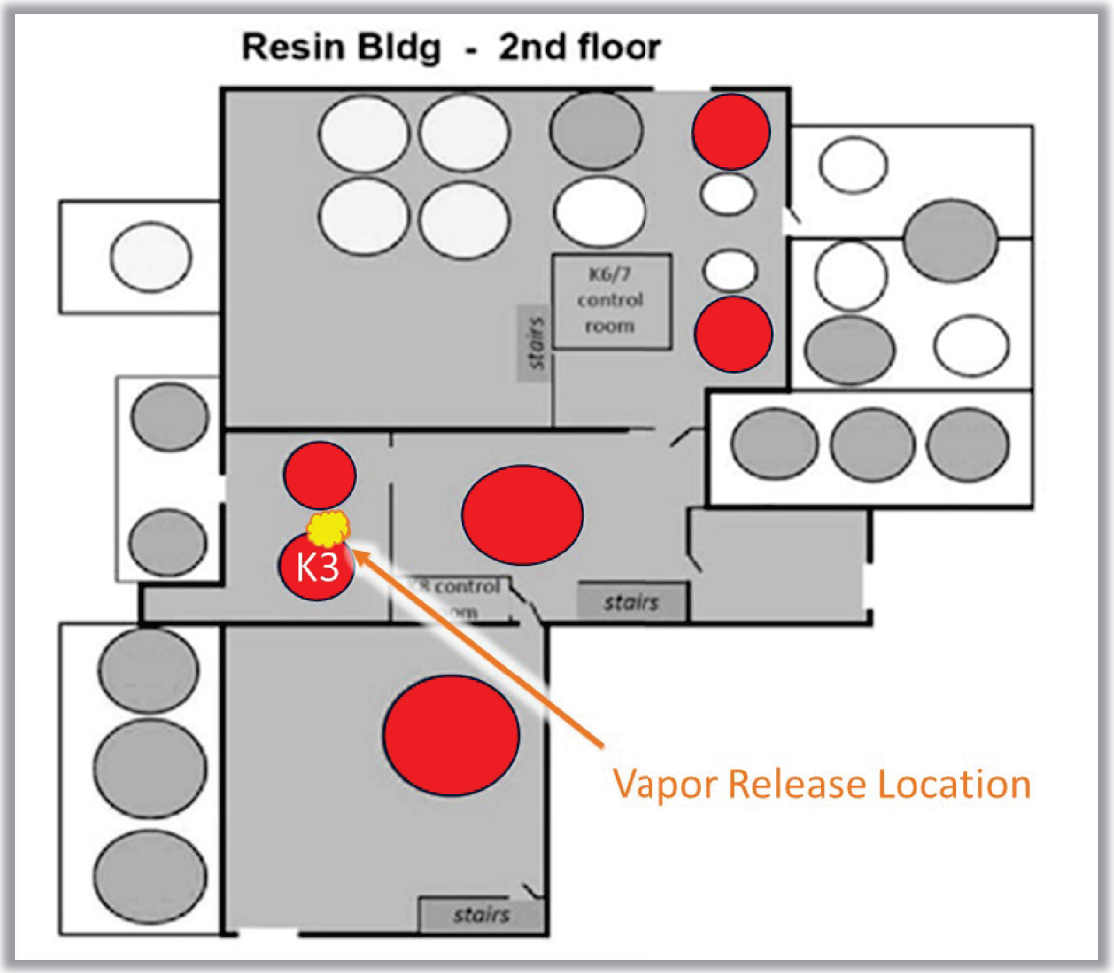
The CSB determined that the cause of the fatal explosion and fire was the release of flammable solvent vapor through the seal of a closed reactor manway that was not designed, constructed, or pressure tested to a design pressure appropriate for the process. The release through the closed manway occurred after the reactor became pressurized by the rapid vaporization of solvent when the reactor's agitator was turned on.

Figure 3. Flammable solvent vapor release location. (Credit: Yenkin-Majestic with modifications by CSB)

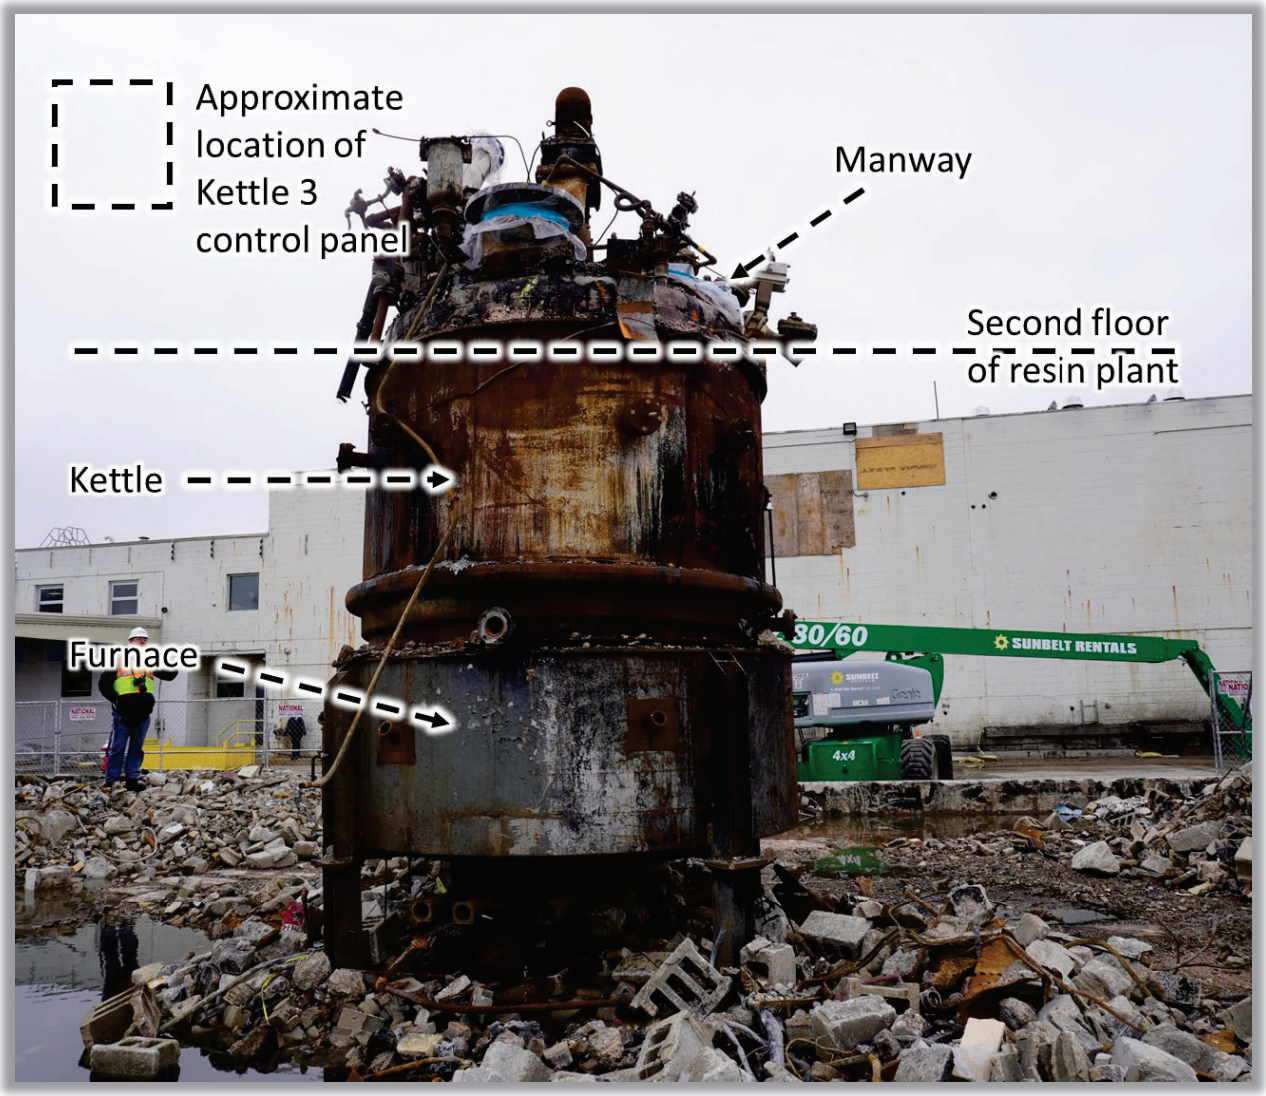
Figure 4. Photo of Kettle 3 during demolition. (Credit: CSB)

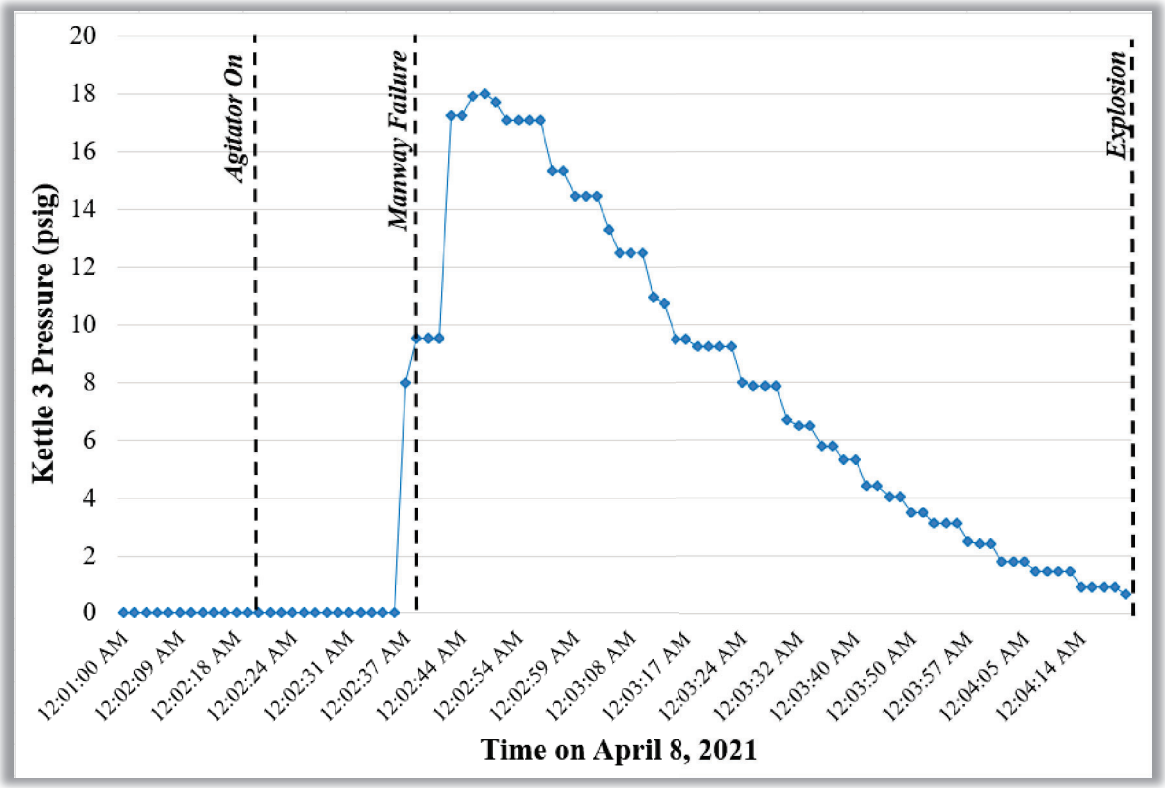
seconds (**Figure 6**). The pressure continued to increase even after triggering the kettle's high-pressure alarm and safety interlock.[a] Two seconds later, when the kettle's pressure reached approximately 9 psig, Kettle 3's closed manway could no longer contain the pressure and began to release a mixture of hot resin liquid and flammable solvent vapor through the sealing surface around its lid into the kettle room (**Figure 7**). At this point, Kettle 3's pressure was still below the rupture disk's marked burst pressure, so it did not relieve Kettle 3's pressure.

Figure 6. Kettle 3 pressure trend during April 8, 2021, incident. (Credit: CSB)

The agitator continued stirring the contents of Kettle 3, and the pressure inside the kettle continued to climb until it peaked at 18 psig, according to control system records (**Figure 6**). At this peak pressure, Kettle 3's pressure was above the rupture disk's marked pressure setting but still within its burst tolerance range, and it did not burst to relieve Kettle 3's pressure.[a] Flammable solvent vapor continued leaking from the manway sealing

[a] Based on the Kettle 3 rupture disk's marked burst pressure of 16.5 psig and the manufacturer's burst tolerance of plus or minus 2 psi, the rupture disk's maximum burst pressure could have been as high as 18.5 psig, which was higher than the peak pressure of 18 psig observed during the incident.

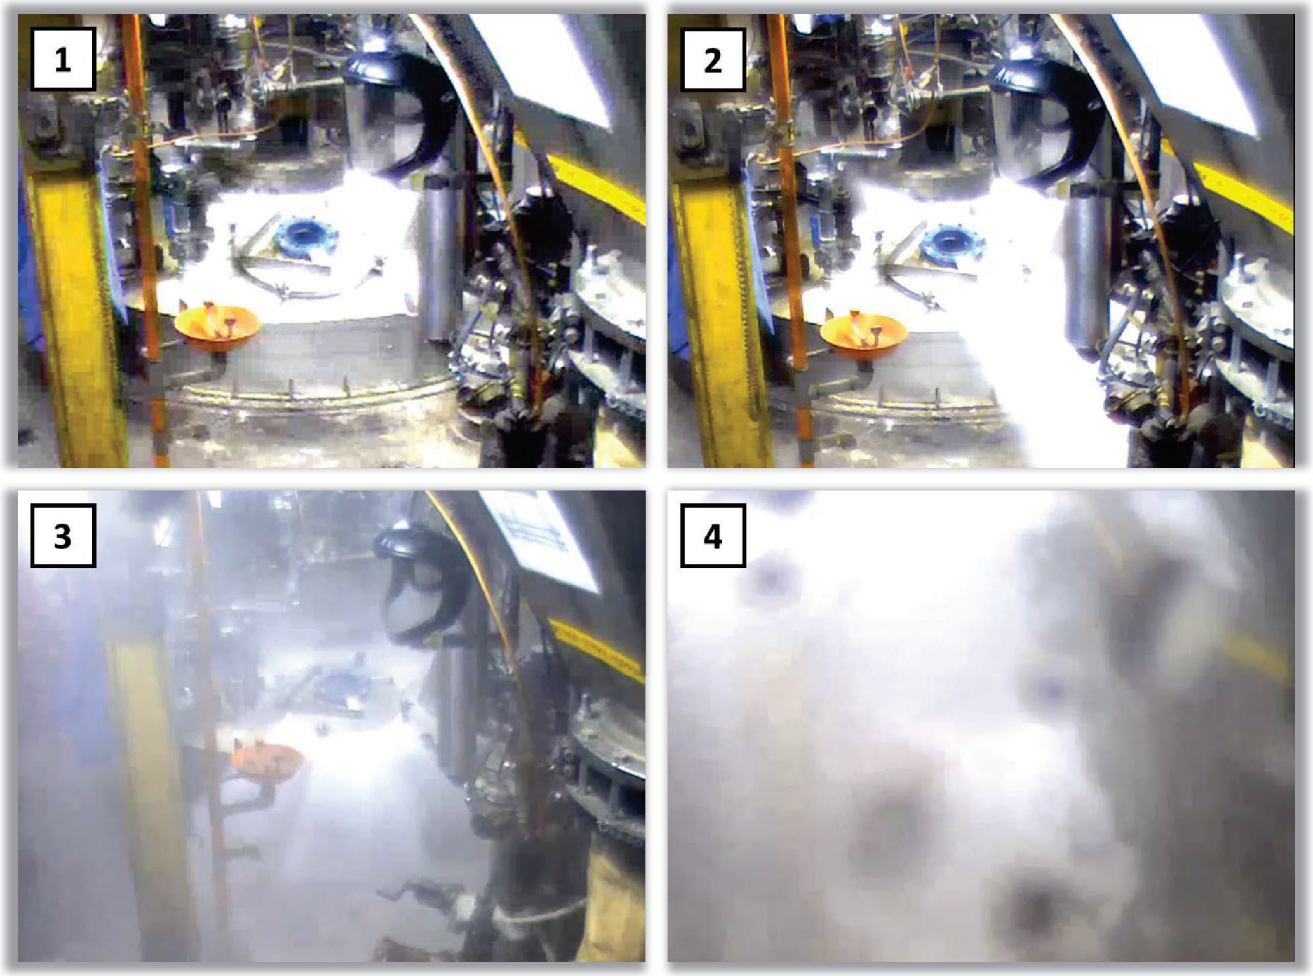
Within seconds, the entire room filled with white vapor, obscuring visibility. Employee A was sprayed by the hot, releasing material and could smell what he later identified to the CSB as flammable VM&P naphtha inside the room.

Figure 7. Initial six seconds of the vapor release from Kettle 3. (Credit: Yenkin-Majestic, annotations by CSB)

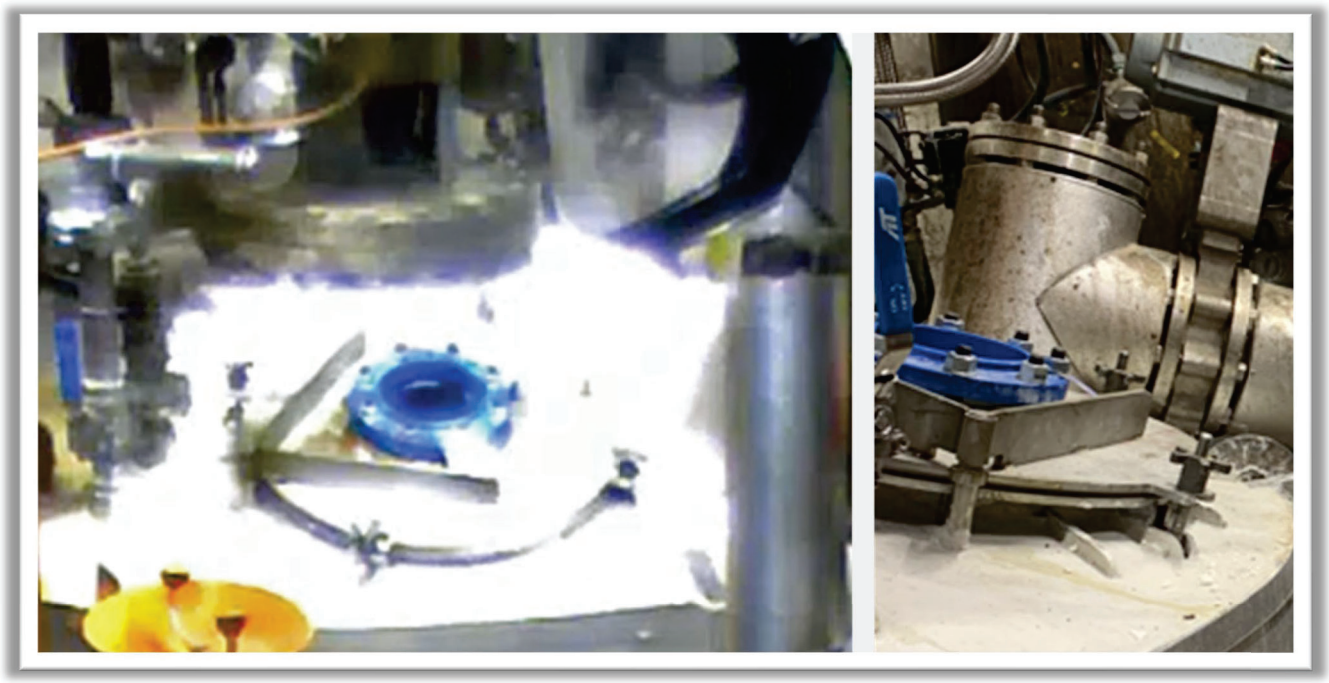
[d] According to Yenkin-Majestic employees, the gasket between the manway's sealing surfaces at the time of the incident was a 1/2-inch-thick gasket that Yenkin-Majestic had cut from a large sheet. Yenkin-Majestic employees also indicated that a spare gasket of the same material had been cut so a replacement would be readily available if needed. While the spare gasket for the manway was retained, no gasket material from Kettle 3 itself could be recovered post-incident due to fire damage.

Figure 10. Photos of the new manway during normal operation. (Credit: Yenkin-Majestic)

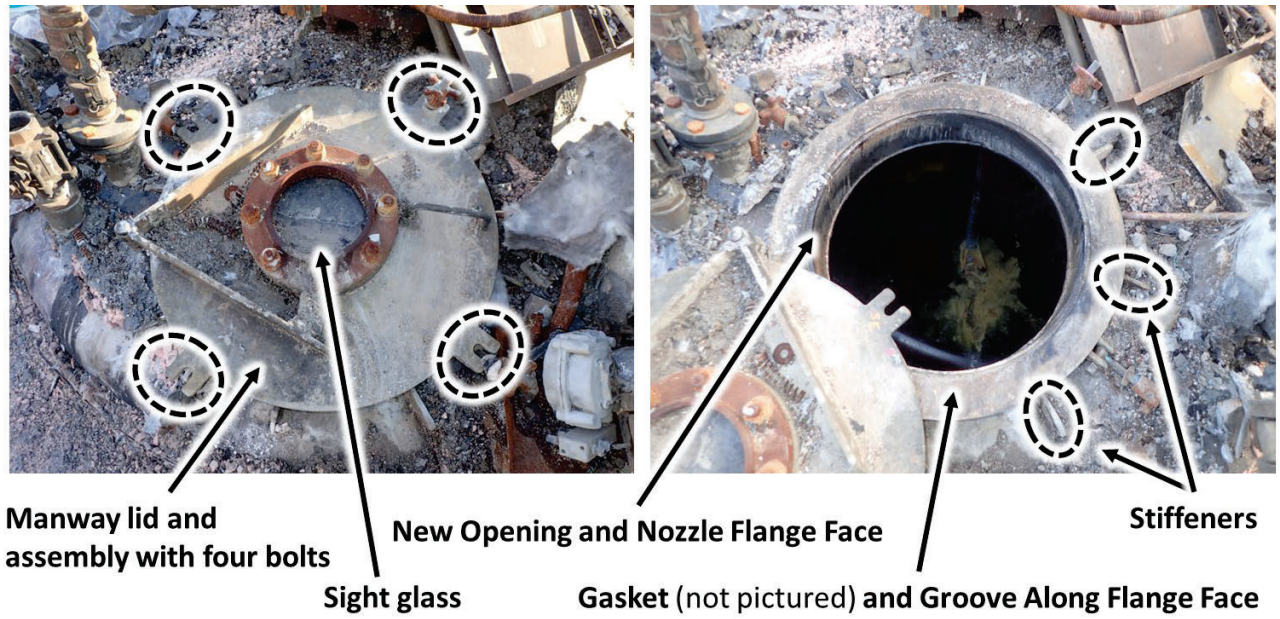
Figure 11. Photos of the new manway after the incident (closed, *left*; open, *right*). (Credit: Rimkus, with annotations by CSB)

Post-incident, the CSB commissioned an engineering evaluation of the manway's mechanical design. Prior to the incident, Yenkin-Majestic had provided the companies designing the new manway with a design pressure of 16 psig, with the assumption that Kettle 3's rupture disk was set to a marked burst pressure less than 15 psig (discussed further in *Section 4.1.1*). The CSB therefore requested evaluations of whether the manway could withstand 16 psig as Yenkin-Majestic had specified. The consultant evaluated several cases to model the

> None of the [modeled] cases were found to achieve a MAWP of 16 psig. The most likely [case scenario] is seen to [provide a MAWP of] 0.82 to 1.28 psig [...] with [another modeled case] providing a range of 3.27 to 5.11 psig.

> For the requested design case, an 8-bolt (0.750-in diameter) design was evaluated [...] at 16 psig MAWP and at 500 F. The required thicknesses [of the lid] for the loose flange, integral flange, and flat cover (blind flange) are 1.75", 1.625", and 0.875", respectively.

Update mechanical integrity procedures for all process vessels in highly hazardous chemicals service, including pressure vessels not exceeding 15 psig, to adopt alteration guidance in API 510 *Pressure Vessel Inspection Code* or Part 3 of the *National Board Inspection Code*.

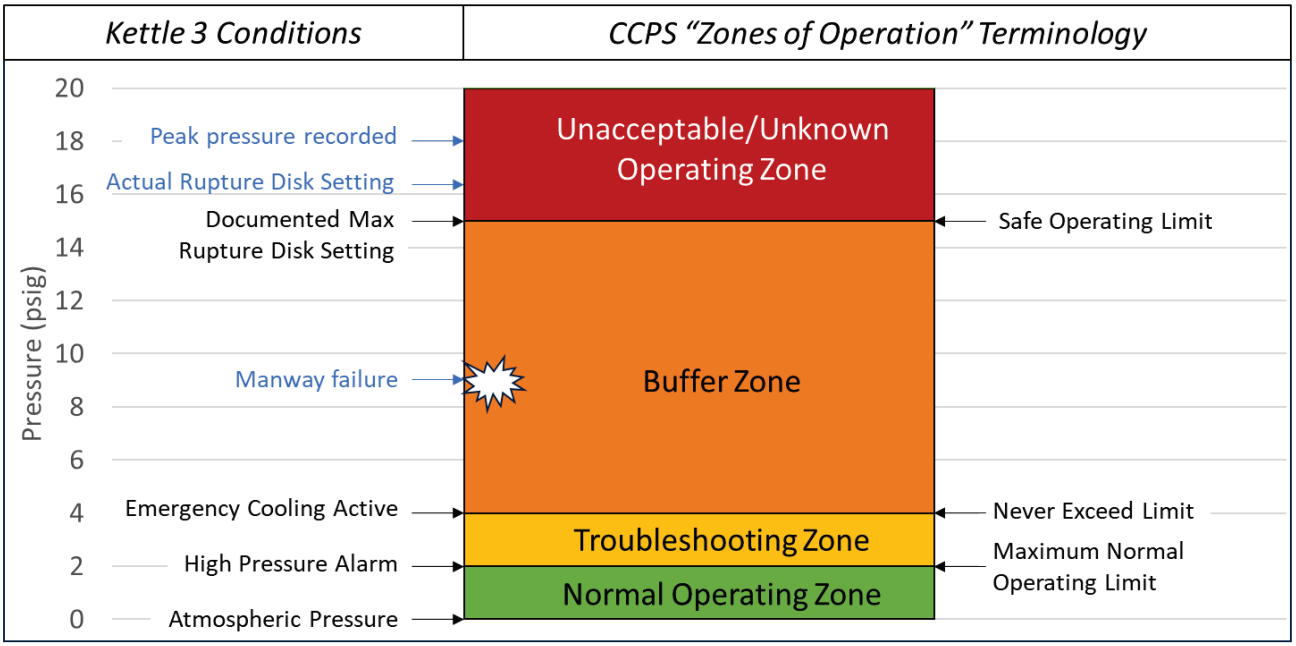
Figure 14. Kettle 3 zones of operation. (Credit: CSB with source material from CCPS [17])

Figure 14 is adapted from the CCPS "zones of operation" diagram to describe how Kettle 3's operating parameters corresponded to the CCPS-defined terminology based on Yenkin-Majestic's documentation. The black text describes Yenkin-Majestic's process safety information for Kettle 3, and the blue text shows actual corresponding pressure recorded on the day of the incident. Although Kettle 3 typically operated at atmospheric pressure, Yenkin-Majestic had configured it with a high-pressure alarm at 2 psig, as well as an emergency cooling interlock and alarm at 4 psig, and had documented that it had a pressure relief device (the rupture disk) set to burst between 13.5 and 15 psig. The incident occurred in what the CCPS describes as a "buffer zone," which should have been Kettle 3's safe operating zone between the emergency cooling interlock activation pressure (4 psig) and the maximum documented rupture disk burst pressure (15 psig).[a]

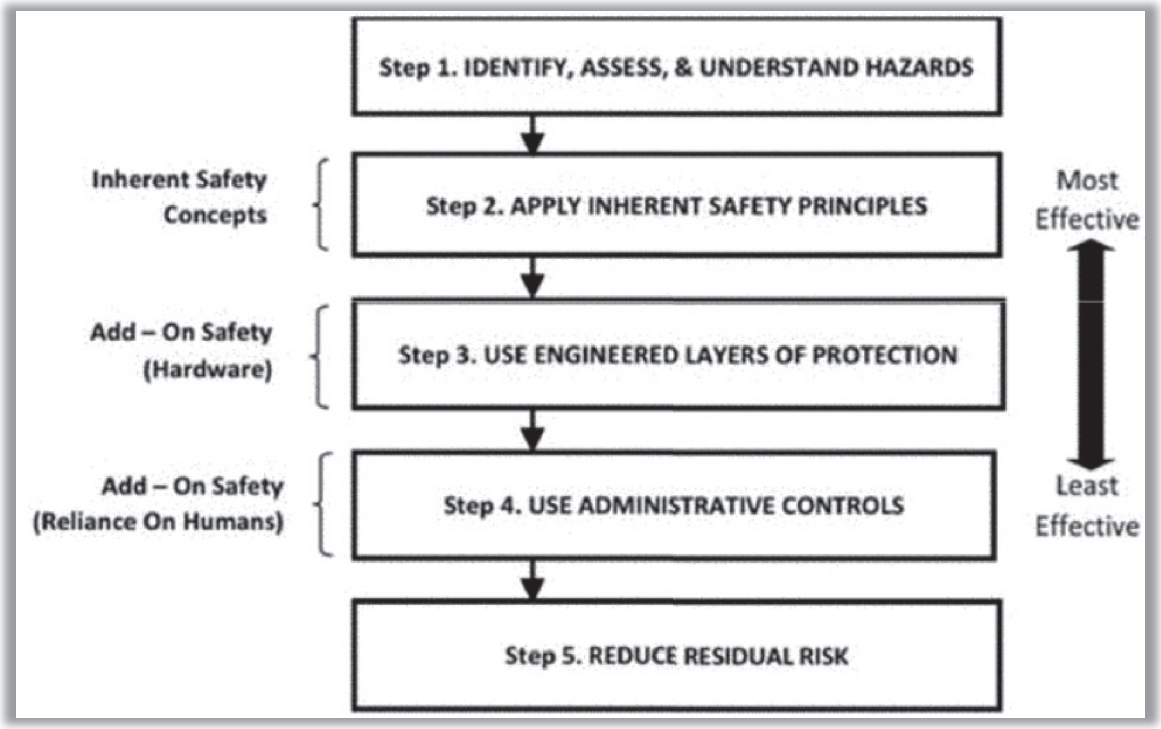
Figure 15. Hierarchy of controls in process safety management. (Credit: CCPS [38, p. 14])

The hierarchy of controls is a risk management principle based on ranking hazard controls from most to least effective: inherently safer design,[a] engineering controls (layers of protection), and administrative controls (**Figure 15**). In general, designing out the hazard and reducing the risk through engineering controls is more effective than using administrative controls. For example, engineering controls reduce hazards through equipment modifications and safety devices, whereas administrative controls include procedures, training, and warnings [37]. Administrative controls are inherently less reliable, because they depend on the performance of personnel for their effectiveness.

This section discusses Yenkin-Majestic's engineering controls and administrative controls for Kettle 3, which did not prevent the April 8, 2021, incident. The absence of engineering controls to prevent the process upset put the responsibility for preventing the incident solely on the operator. The discussion concludes with suggestions for designing safer process plants that can tolerate human error and equipment failure (e.g., in this case, agitator shutdown) to prevent catastrophic consequences.[b]

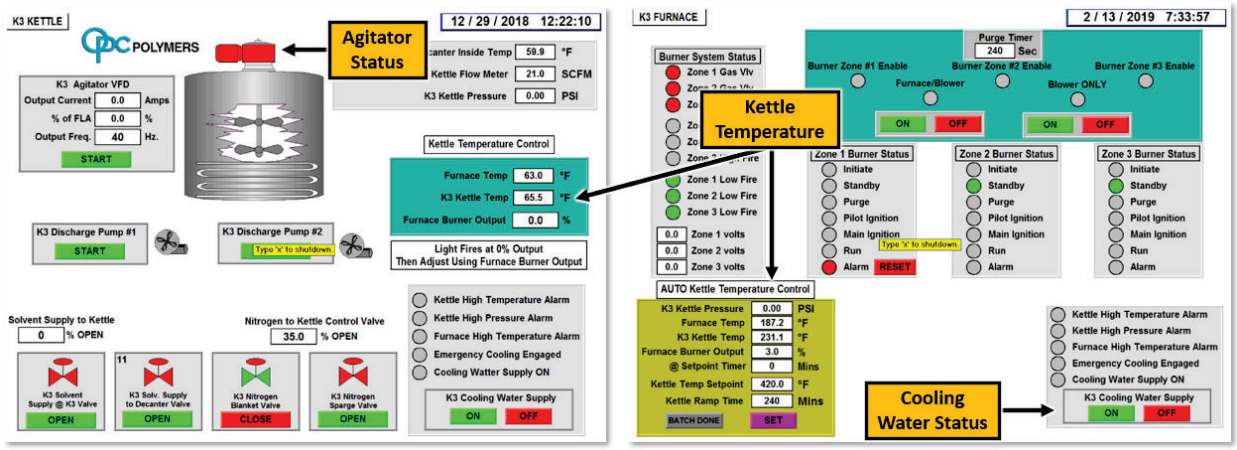
agitator at the beginning of a batch, it typically remained running for the duration of the batch. There was no process alarm to warn the operator if the agitator shut down in the middle of a batch.

Figure 16. Generic Kettle 3 HMI screen layouts. (Credit: Yenkin-Majestic with annotations by CSB)

On the night of the incident, Employee A did not detect that the agitator had unexpectedly turned off while he was not present in the kettle room. Employee A told the CSB that after he returned and pushed the "Batch Done" button, he monitored Kettle 3's temperature and pressure from the furnace screen, which did not indicate the agitator's on/off status.[a] Employee A noticed that the agitator had turned off only when it became evident that the kettle had not cooled at the expected rate, approximately 100 minutes after the agitator shut down. At that point, he had already added 300 gallons of solvent into the kettle. Furthermore, he did not know how long the agitator had been off—whether it had turned off before he had added the solvent or after. Employee A then turned on the agitator not knowing whether or how much of the solvent had mixed with the resin inside the kettle, thus triggering the uncontrolled pressure increase inside the kettle.

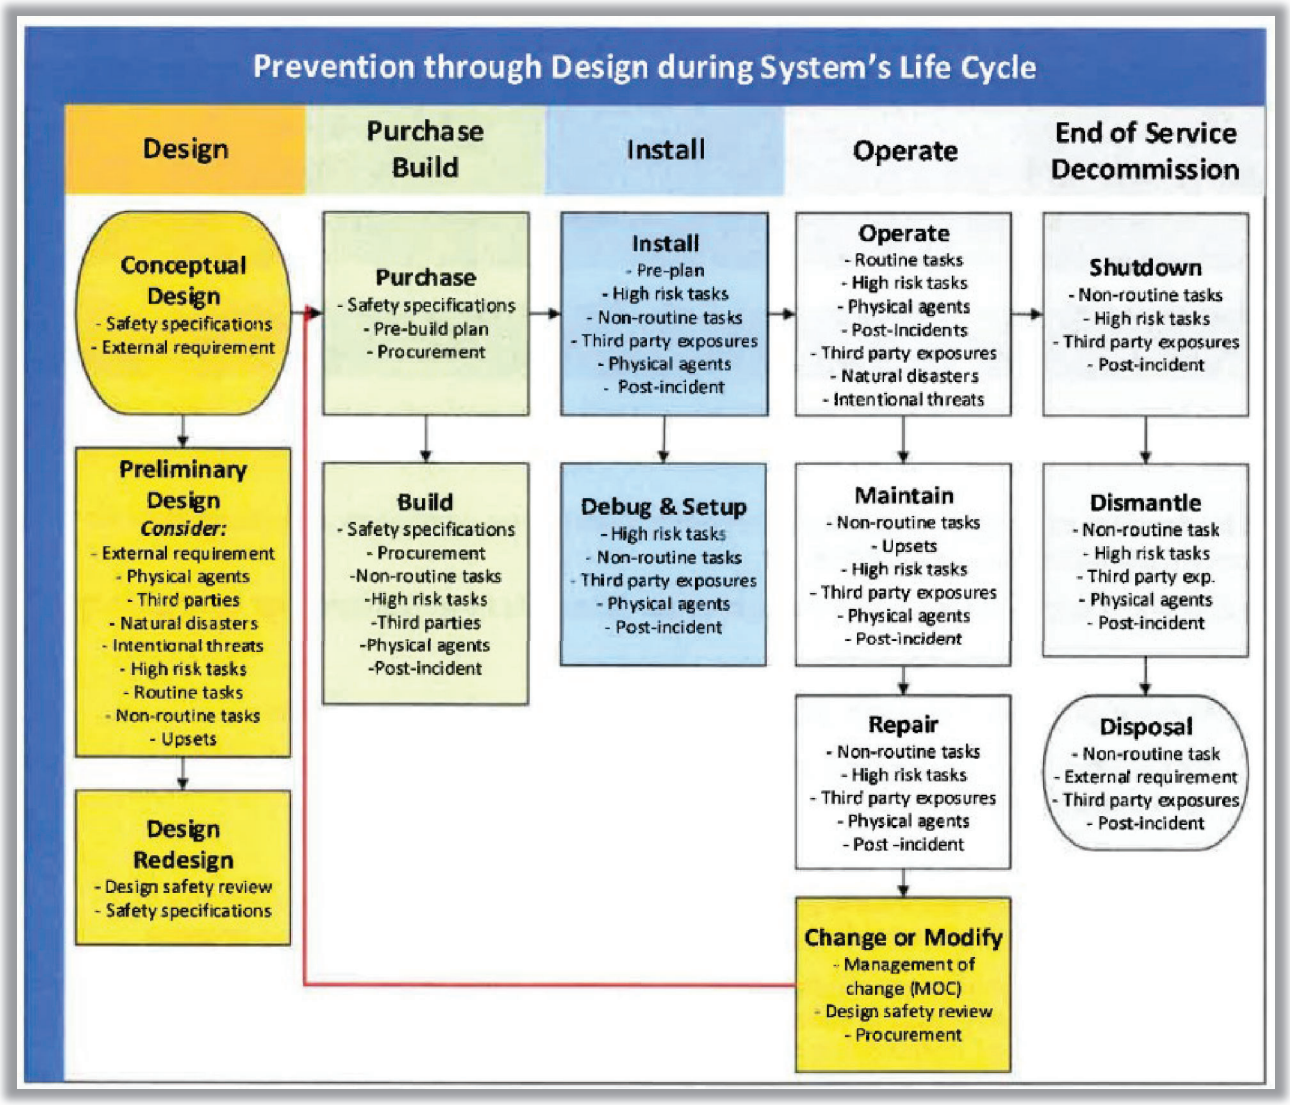
Figure 17. Example of prevention through design opportunities during a system's life cycle. (Credit: ASSP [43])

The above design principles should not be limited to the initial design of a process plant but instead should be used through the plant's entire life cycle. For example, over the course of a process plant's operation, operating data, incident investigations, management of change, and PHAs provide important opportunities to apply the hierarchy of controls. **Figure 17** provides examples of opportunities where these design concepts could be applied across the entire life cycle.

The CSB concludes that applying the hierarchy of controls at the design phase is the best opportunity to ensure that process hazards are properly analyzed and risks are effectively reduced, before the design is implemented in the field. After the design phase, however, when construction is complete and the process is operating, process safety management system elements such as PHAs, incident investigations, and management of change are important opportunities to apply the hierarchy of controls to further reduce risk throughout the life of a process.

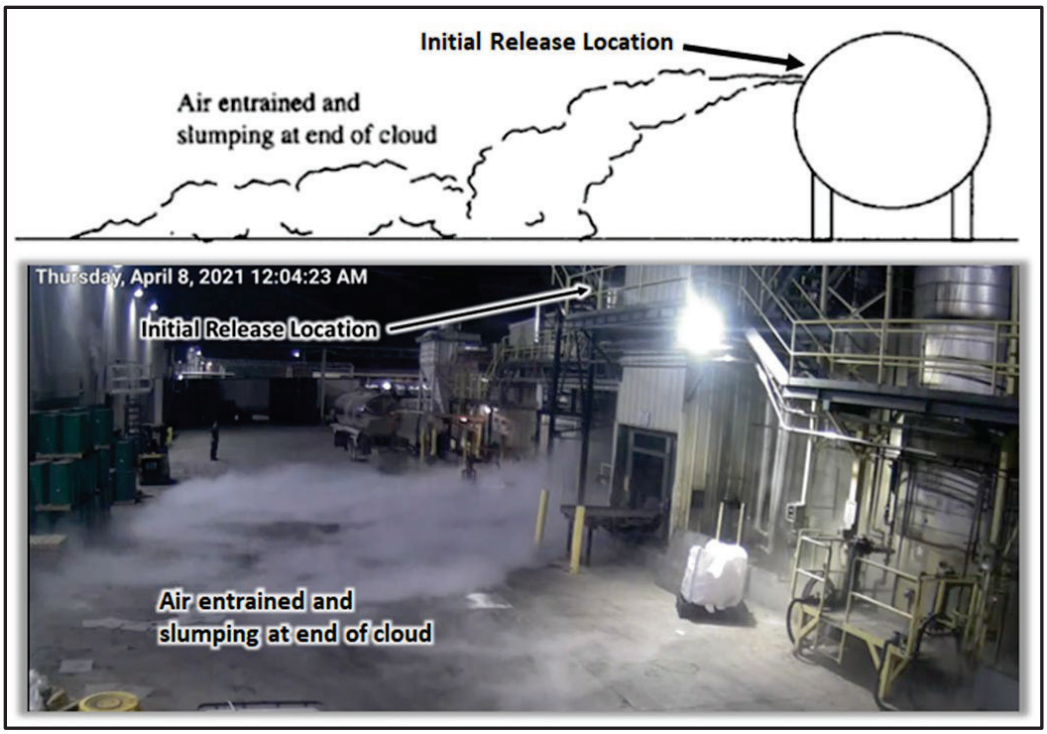
Although upon release a dense vapor cloud may first travel upward, once initial momentum is lost it will start to descend towards the ground due to gravity slumping since it is heavier than the surrounding air [47, p. 284]. **Figure 18** depicts the dispersion behavior of a dense gas compared with a surveillance camera video still of the vapor cloud during the April 2021 release. Comparatively, although saturated high-pressure steam may initially be denser than air upon release, at atmospheric pressure it will begin to rise and dissipate rather than sink and travel at ground level [48].[a]

Figure 18. Comparison of April 2021 observed vapor cloud to expected dense gas behavior. (Credit: *top:* CSB, modified from Wells, 1997 [47]; *bottom:* Yenkin-Majestic with annotations by CSB)

Identify and document all equipment that could release flammable materials and install LEL detectors in accordance with sources and guidance such as *Guidelines for Engineering Design for Process Safety* by the Center for Chemical Process Safety and *Explosion Hazards in the Process Industries* by Rolf K. Eckhoff. Ensure that detection of hazardous conditions automatically triggers both visual and audible alarms to alert plant personnel of the hazard. Develop and implement employee training on actions to take, such as prompt evacuation, when such alarms are activated.
